**FINAL SUMMARY REPORT**

**SEDIMENT MANAGEMENT UNIT 56/57 DEMONSTRATION PROJECT  
FOX RIVER, GREEN BAY, WISCONSIN**

**September 2001**

**Prepared By:  
Montgomery Watson**

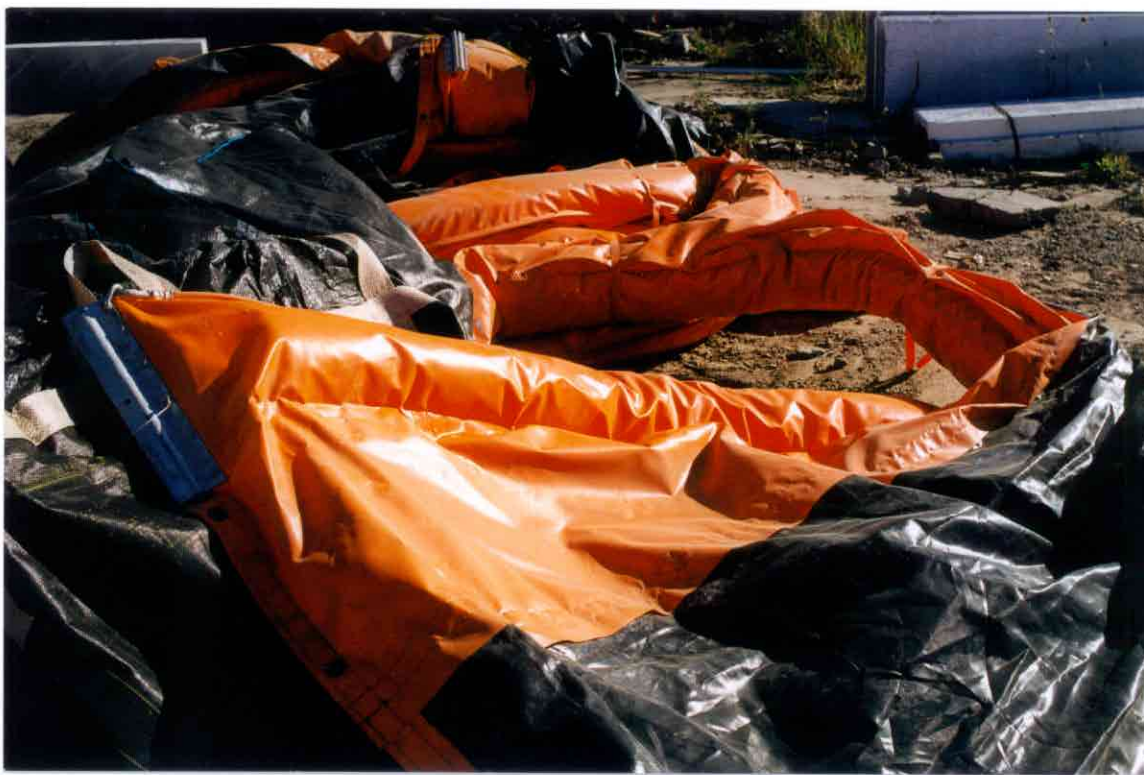
Photo No. 1: Spare silt curtain panel. Note orange floatation, black silt curtain skirt, and slide connector.

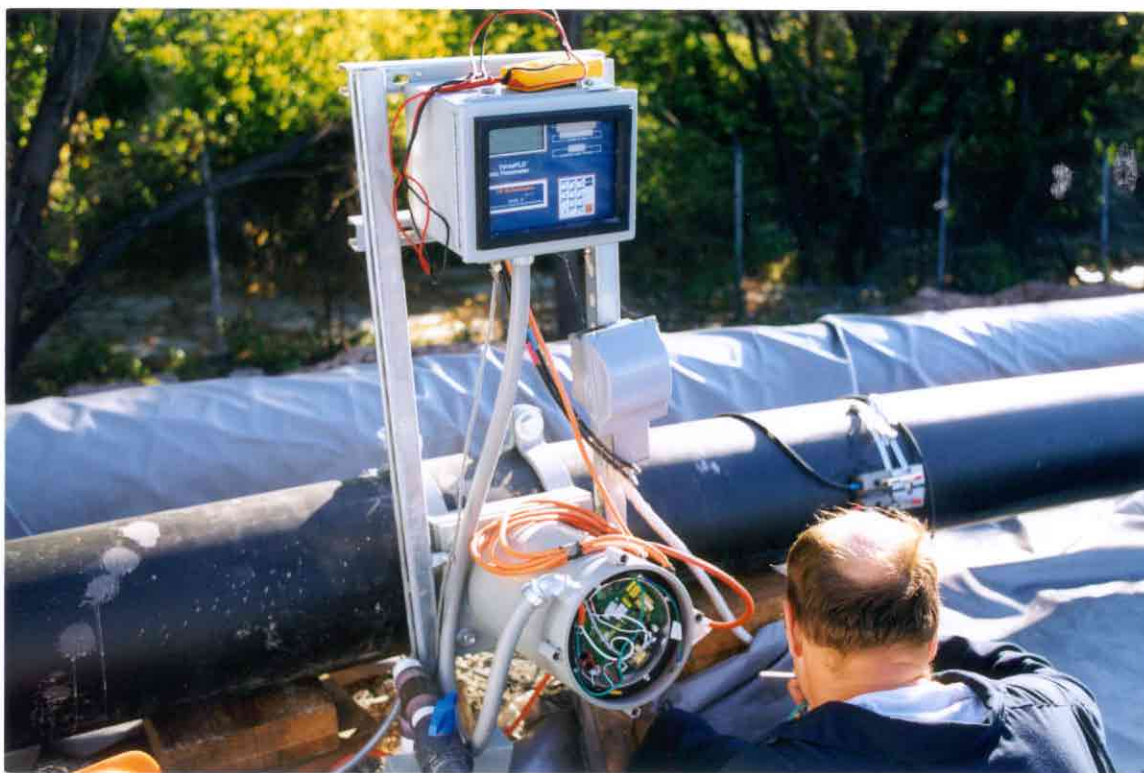
Photo No. 2: Dredge slurry flow meter.

A doppler flow meter was installed on the dredge slurry pipeline to measure slurry density, flow rate, and total flow. However, the dredging subcontractor experienced numerous problems maintaining and monitoring this meter throughout the Project. Examples of the problems included occasional loss of electric power to the instrument, and periodic and random stoppage of the flow meter operation for unknown reasons. This caused gaps in data acquisition, which led the subcontractor to often estimate results in his daily reports. Further, reported daily values for slurry density (in dry tons) consistently overstated the dredged mass removed, based on comparison to in-river dredge surveys and percent solids test results on slurry samples. For these reasons, Montgomery Watson considers the data to be unreliable and a discussion of the results is not included herein.

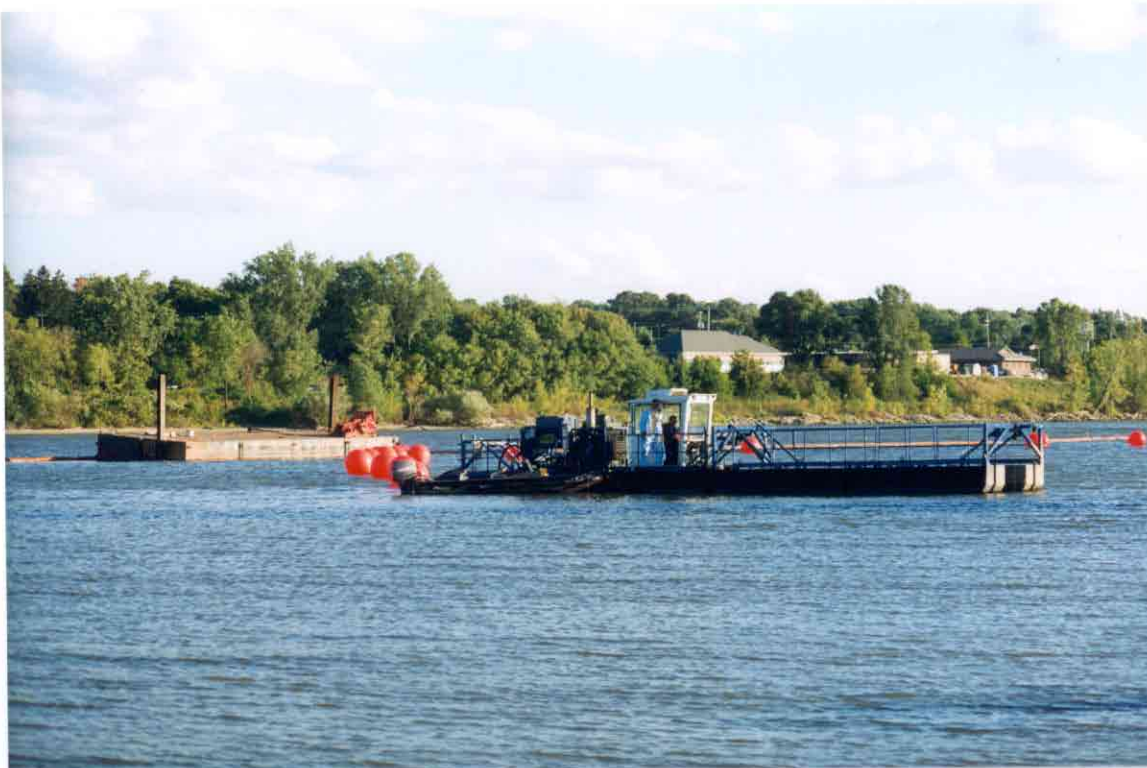
Photo No. 3: IMS 5012 Versi-Dredge in river.

A hydraulic dredge with 12-in. pump and round cutterhead was mobilized to the site, and dredging began on August 30, 1999 in Subunits 12 and 23. After about one week of intermittent dredging, an IMS 4010 Versi Dredge (10-in. pump discharge) was mobilized to the site to try to increase solids content in the dredged slurry. It replaced the dredge initially mobilized. The IMS 4010 dredge began operation on September 5, 1999 with an in-line booster pump on shore near the north end of the dredge area to convey the slurry to the equalization basins. This dredge was replaced with an IMS 5012 Versi Dredge (12-in. pump discharge) and a larger booster pump on September 10, 1999. The IMS 5012 dredge had a six-cylinder diesel engine rated at 250 HP at 2,200 rpm. The dredge pump had a 9.75-in. diameter intake and a 19.25-in. diameter impeller. It was rated for a flow of 5,000 gpm at 85 ft total dynamic head and speed of 800 rpm. The booster pump was an 8-in. MXT Pekor Pump, with engine rated at 250 HP. The 8-in. diameter intake and discharge were converted with pipe fittings to a 12-in. diameter intake and discharge. It had a 25-in. diameter impeller. On September 22-23, 1999, a wider horizontal auger cutterhead (9-ft long by 22-in. diameter) was placed on the IMS 5012 dredge. This configuration was used for the remainder of the Project ([Photo Nos. 3, 4, and 5](#)).

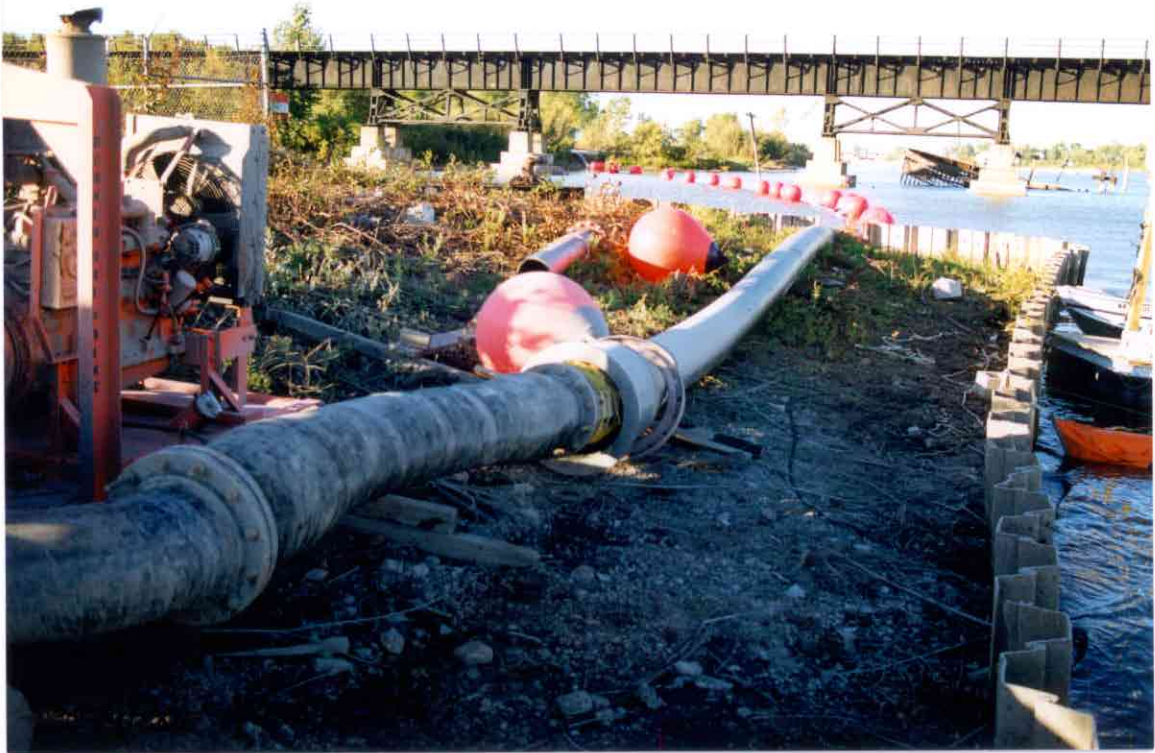
Photo No. 5: On-shore booster pump.

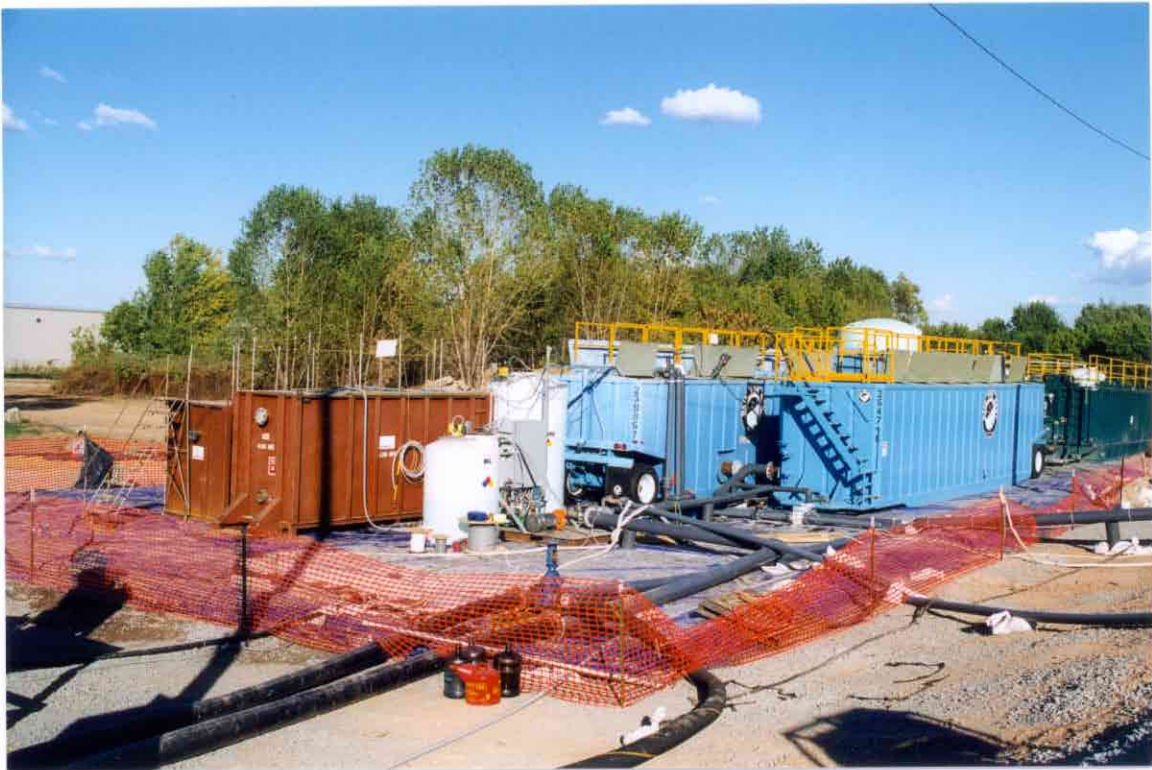
Photo No. 7: Water treatment - chemical addition and flocculation/equalization.

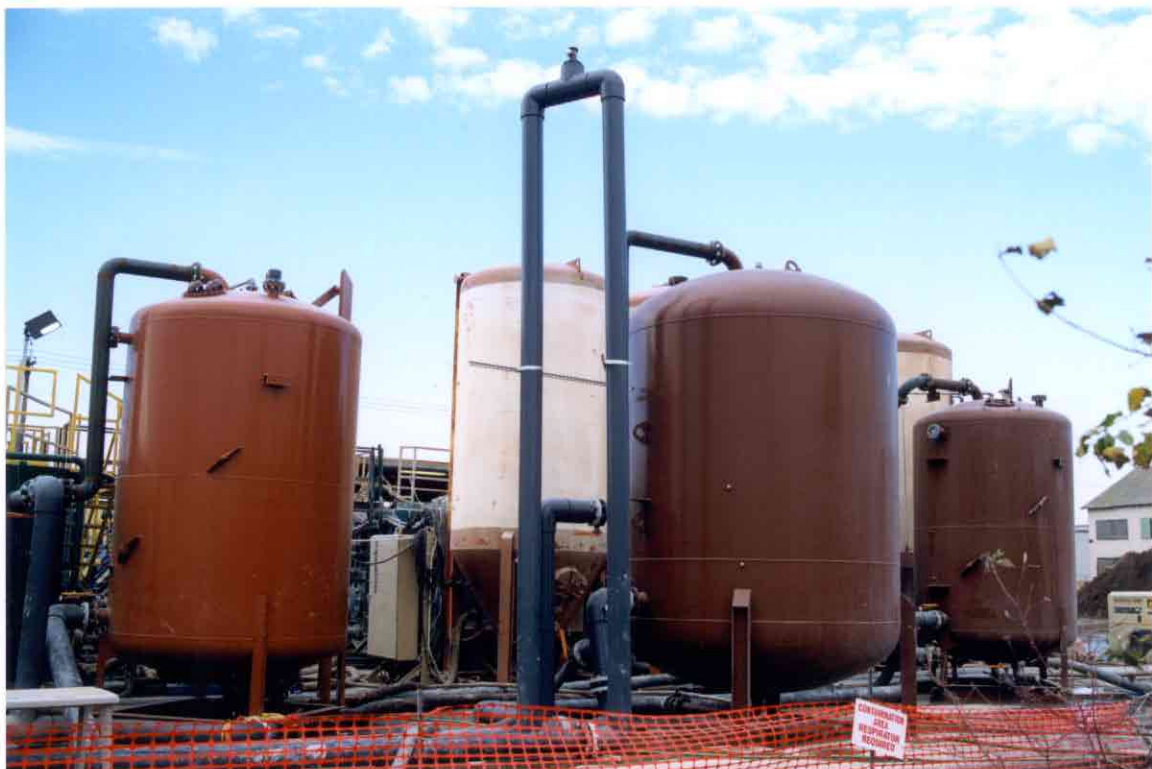
Photo No. 8: Water treatment - filtration and granular activated carbon.

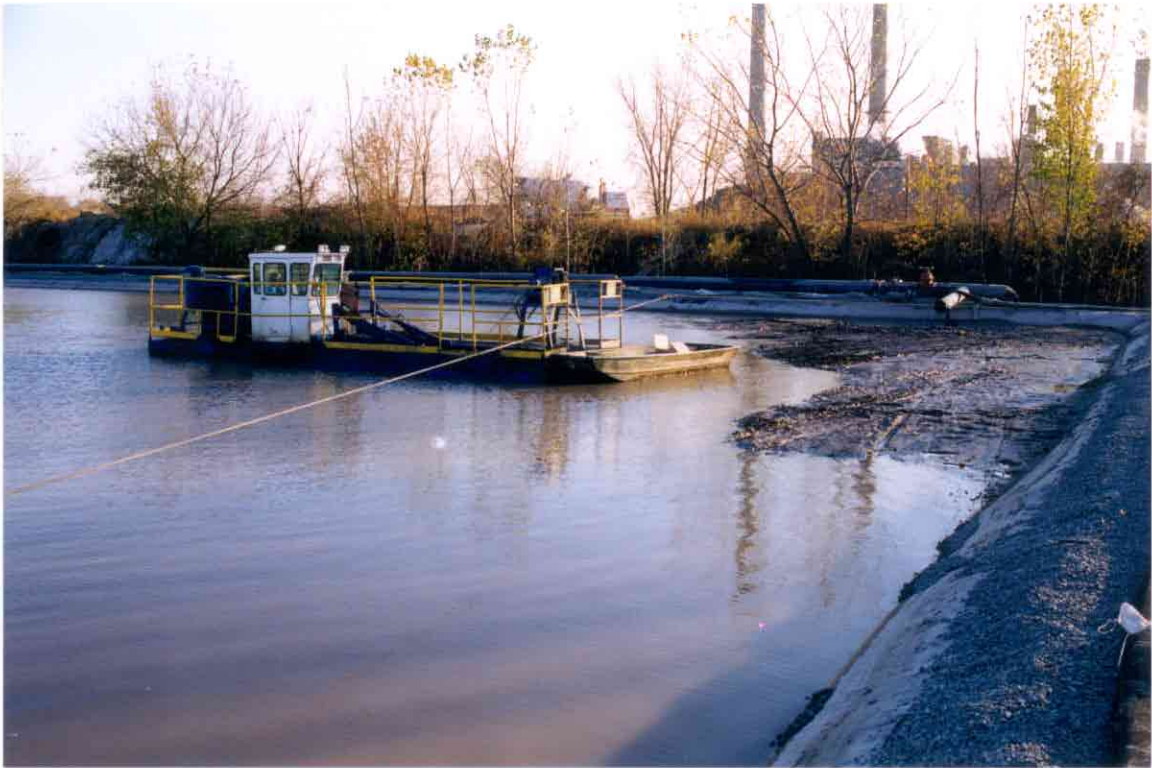
Photo No. 9: Small hydraulic dredge in west equalization basin. Note anchor and travel cables, and slurry discharge pipe.

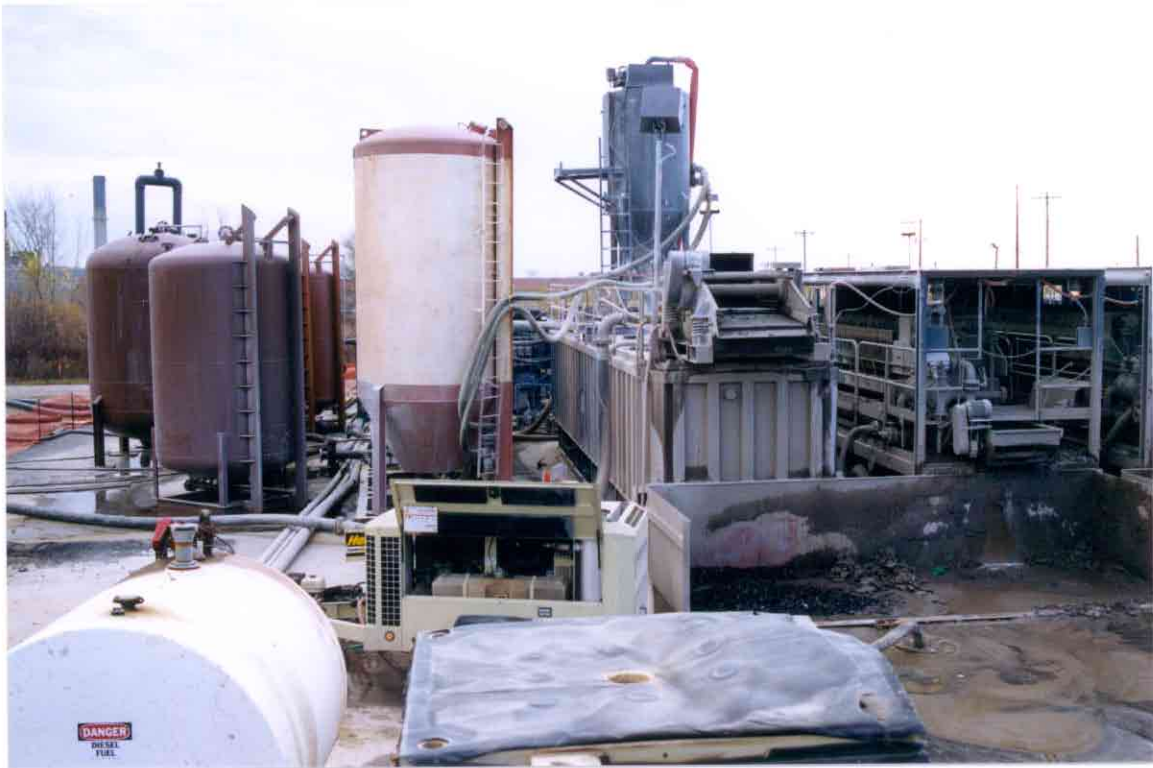
Photo No. 10: Slurry shaker mix tank, lime storage tanks, and lime feed system.

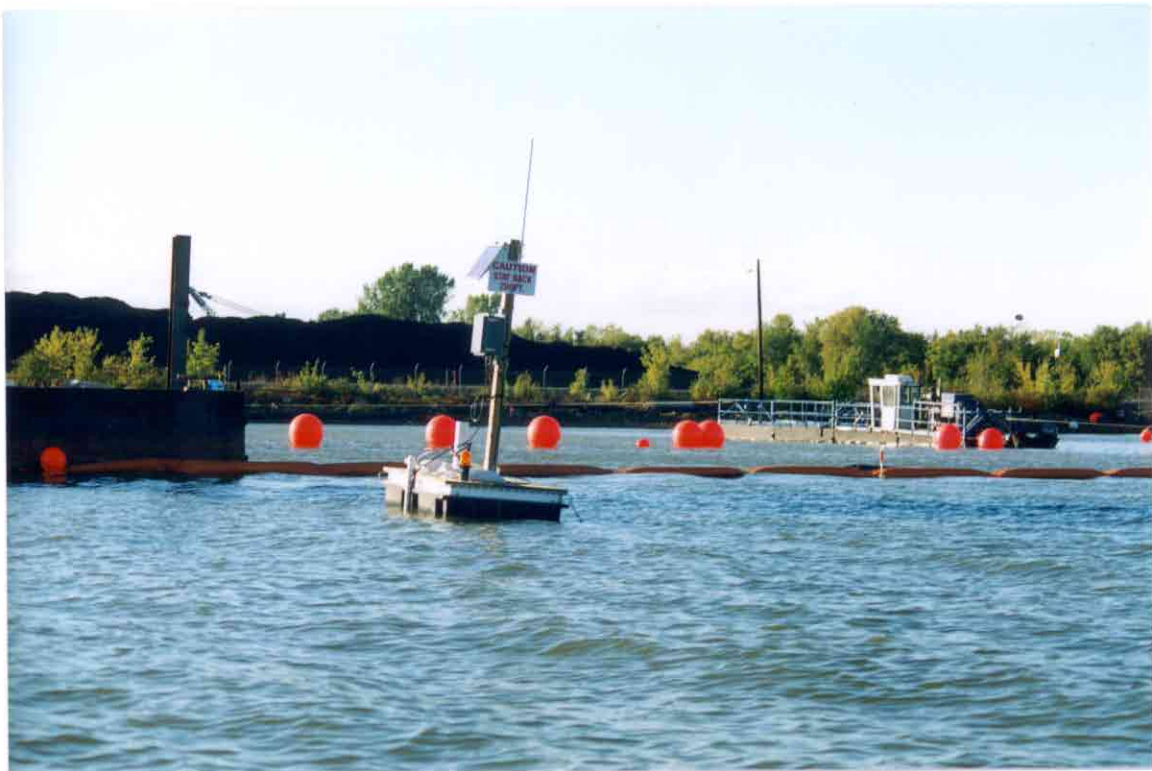
Photo No. 18: Real-time turbidity monitor on a float at the sidestream position outside the silt curtain. Also note the anchor barge, silt curtain, dredge pipeline floatation, and dredge.

The real-time turbidity monitors in the river (USO, USI, SSO, DSO, DSI) were initially installed on custom made floats approximately 4 ft by 5 ft in size ([Photo No. 18](#)), anchored at each corner with a rope tied to a concrete block. However, instability problems with the floats in rough water led Montgomery Watson to replace the floats with 6-in. or 8-in. diameter steel pipe piling ([Photo No. 19](#)), which were installed for us by McMullen & Pitz on October 5, 1999. A battery-powered, flashing amber beacon was installed at each river monitoring station. The turbidity monitor and transducer at FJI were installed on a wooden pole next to the water intake.

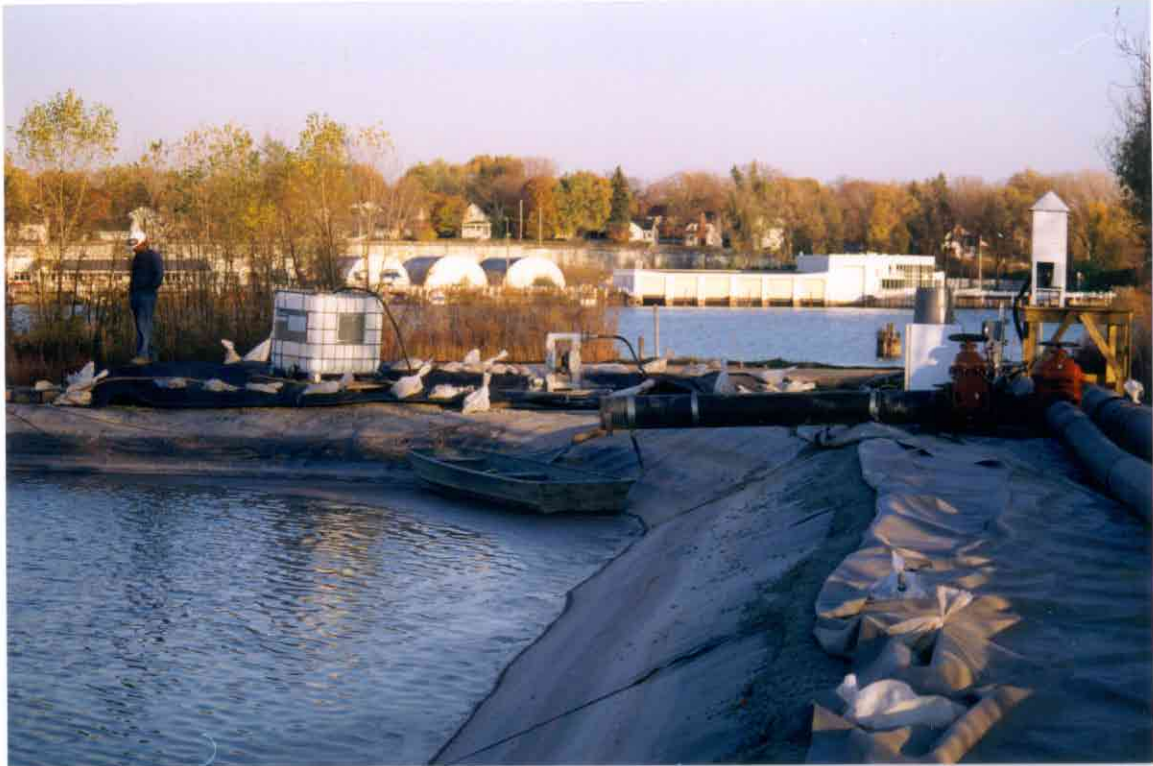
Photo No. 21: Dredge slurry sampling station at southeast corner of east equalization basin. Note valves on slurry pipe.
